**FSI****FIELD  
SERVICE  
INFORMATION**

Product DS90 Floppy/Databoard interface board  
Artikel

Product DS90 0.5/2 Mb memory board  
Artikel

Product DS90 M68010 CPU board  
Artikel

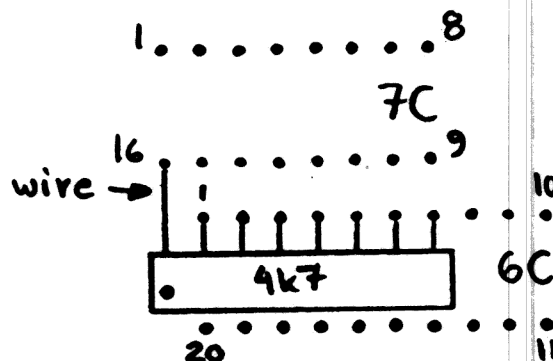
CPU boards with floating point option installed

**Problem:** Poor noise immunity when floating point option is installed.

**Action:** Apply seven (7) 4.7K pullup resistors on the solder side of the board as follows:

Place a 7\*4.7K SIL resistor network between the two rows of pins in position 6C (PAL16L8A PAT8022) and connect pins 2-8 of the SIL net to pins 1-7 on the IC.

Pin 1 on the SIL net should be connected to pin 16 (+5V) on the IC in position 7C.

Please refer to drawing below as seen from the solder side.
